# J.G. Whittier Middle School

Haverhill, MA

School Building Committee

October 14, 2026

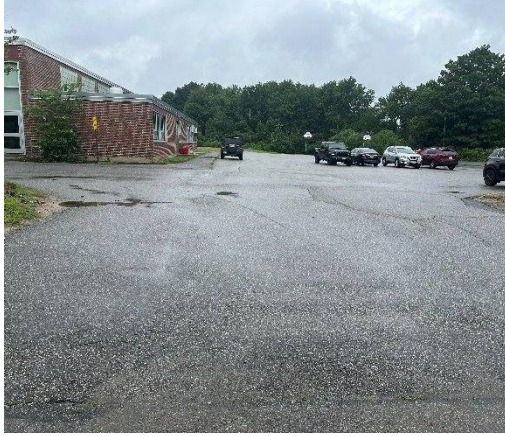
Driveway & Parking Lot

Driveways, parking lots, walkways, and curbing are in fair to poor condition, with extensive cracking and deterioration throughout. Sidewalks are in fair to poor condition, and curb cuts generally lack required tactile warning panels and striping at crosswalks. No ADA compliant van-accessible parking space or accessible parking spot with loading zone, tactile warning panel, and signage. Drainage and utility structures show signs of age.

Reconstruct deteriorated pavement, curbing, and sidewalks to current MAAB/ADA standards, and inspect/clean the stormwater and sewer systems. Utility infrastructure will likely need to be updated as part of any project.

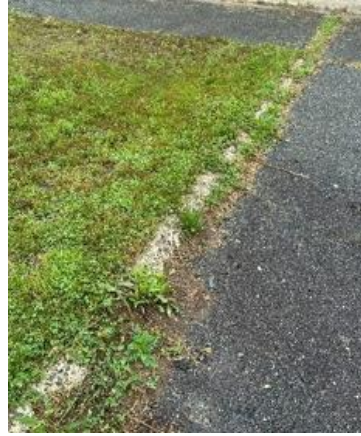
Deteriorated concrete curb

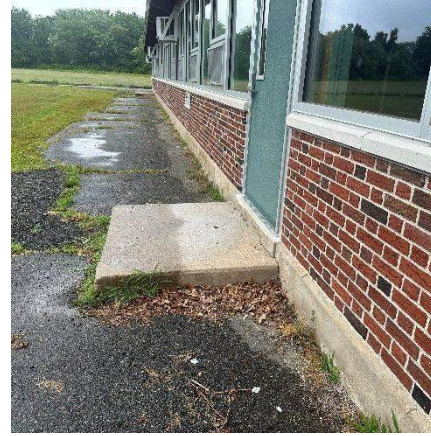
Sidewalk Cracking

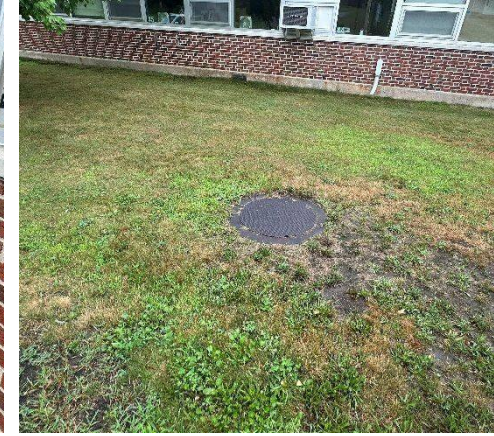
Unmarked Manhole

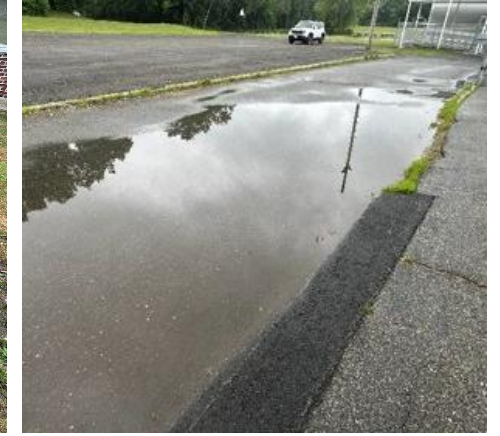
Drainage Ponding

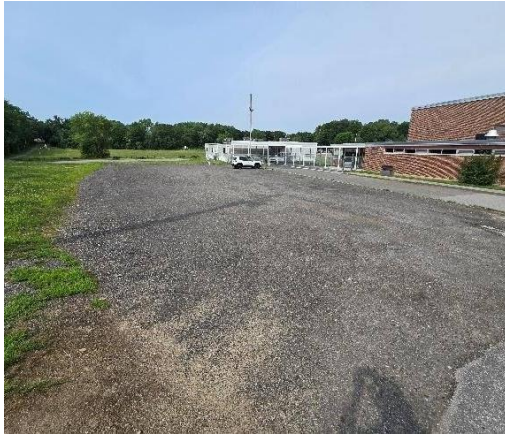
Gravel Parking Area

The gravel parking area serving the 2024 modular addition is unstriped and in poor condition.

Resurface the parking area and court pavement, address accessibility at egress doors, regrade poorly-drained lawn areas, and anticipate Conservation Commission permitting near mapped wetlands.

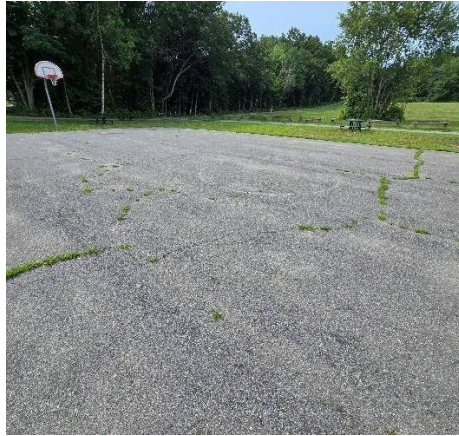
Basketball Court

The basketball court is in poor condition, and athletic field backstops no longer appear in active use.

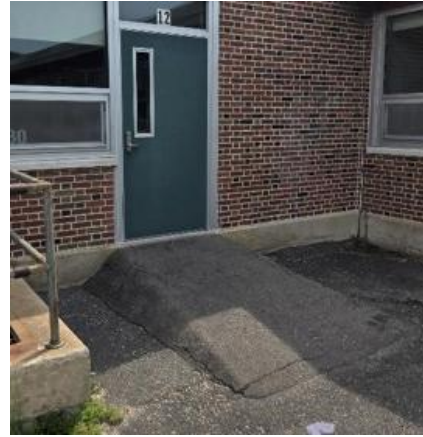
Accessibility Challenges

Asphalt ramps at several building entrances exceed accessible slopes

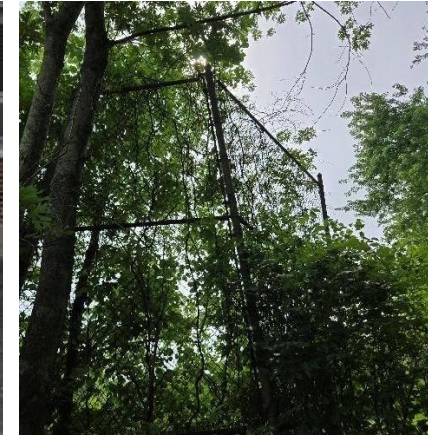
Athletic Field Backstops

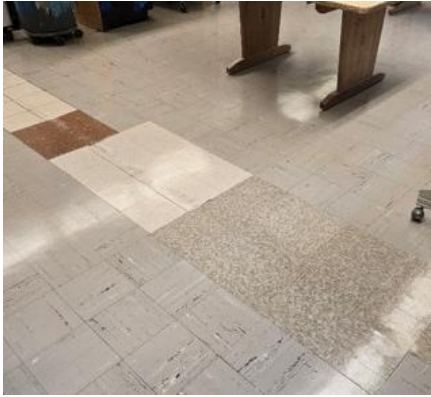
Corridor Flooring

Classroom and corridor flooring is a patchwork of tile types, and the original gym floor is buckled and worn.

Replace flooring, ceilings, and non-compliant doors/hardware in a renovation, and reconfigure toilet rooms to meet MAAB/ADA standards.

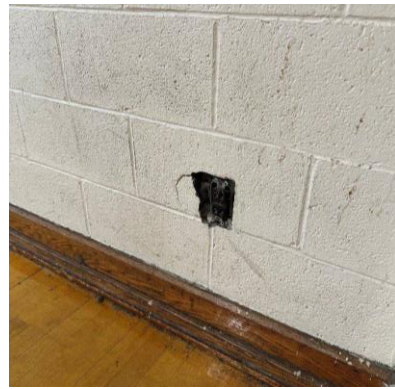
Interior Wall Damage

Some interior walls show damage around utility penetrations, and ceilings show staining from roof leaks.

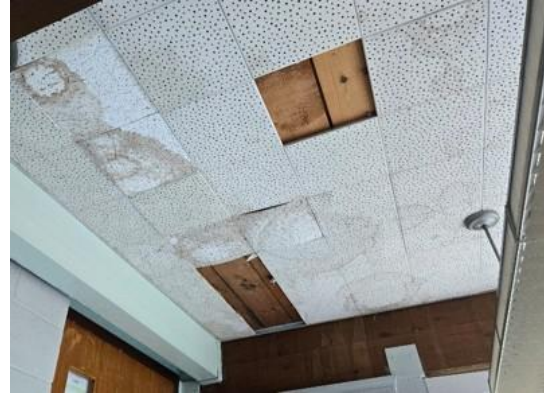
Ceiling Water Damage

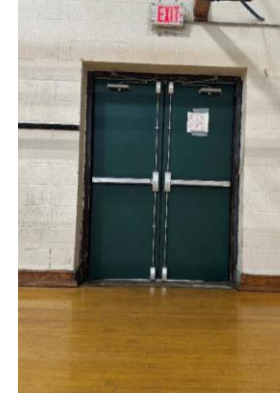
Non-Compliant  
Hardware

Gymnasium egress doors have rusted frames, damaged gaskets, and warped leaves that do not seal.

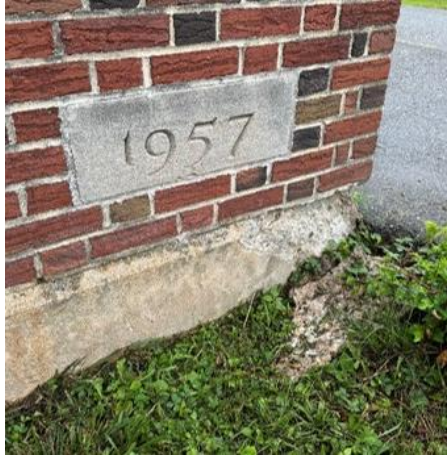
Masonry Spalling

Original brick masonry is in good overall condition, with isolated spalling at several concrete foundation corners.

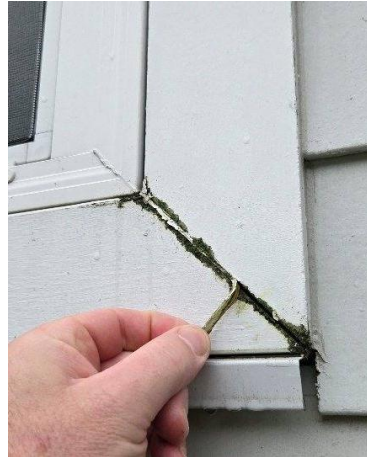
Window Sealant Failure

Window joint sealant has failed at both the 2012 windows and the modular addition, with visible mildew and water intrusion.

Address canopy, roofing, and sealant issues as near-term maintenance, and replace window AC units with central/split cooling in a major renovation.

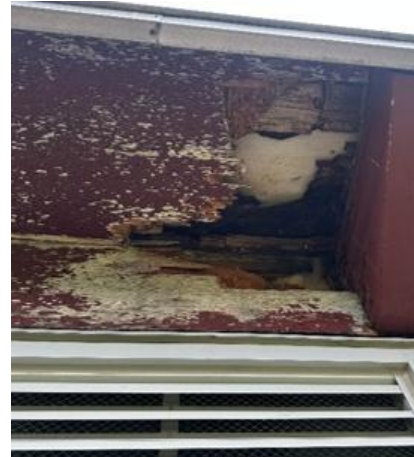
Deterioration of Plywood  
Soffit and Frieze

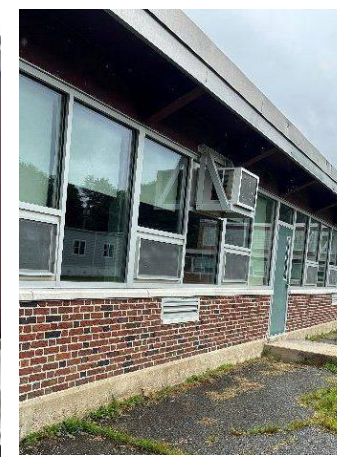
Window-Mounted  
AC Units

Window-mounted AC units are inefficient, drip condensate onto walls and give birds places to nest.

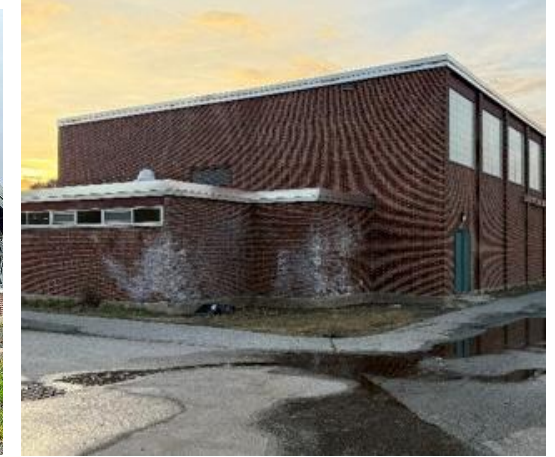
Efflorescence at masonry

Several locations show severe efflorescence, moisture damage and mortar erosion.

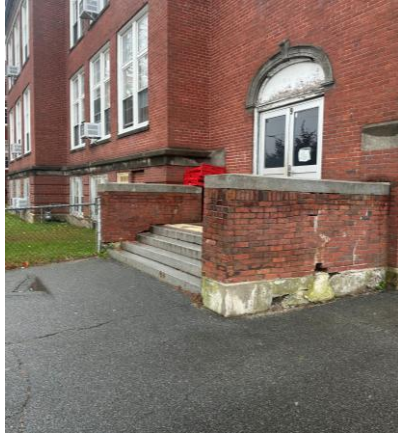
Spalled Concrete at Entry

Rebuild paving, sidewalks, and ramps to MAAB/ADA standards and update utilities. Replace interior finishes, doors, toilet rooms, and the MEP and technology systems. Add sprinkler system.

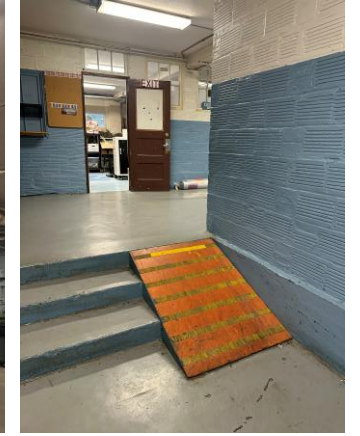
Non-Compliant Ramp

**Landscape:** The gravel lot and basketball court are poor, lawns drain poorly, and entry ramps exceed accessible slopes.
