# J.G. Whittier Middle School

Haverhill, MA

School Building Committee

October 14, 2026

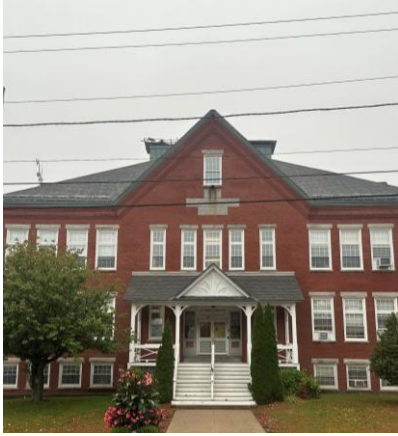
Front Façade

**Exterior:** Masonry is sound but needs some repointing, the chimney cap is damaged, accessibility is limited, and the roof is fair to good.
